September 29, 2020

Project No. 20147153(1000)

**PRE-RENOVATION DESIGNATED SUBSTANCE AND HAZERDOUS MATERIALS ASSESSMENT SURVEY –  
1615 DUNDAS STREET EAST, WHITBY, ONTARIO**

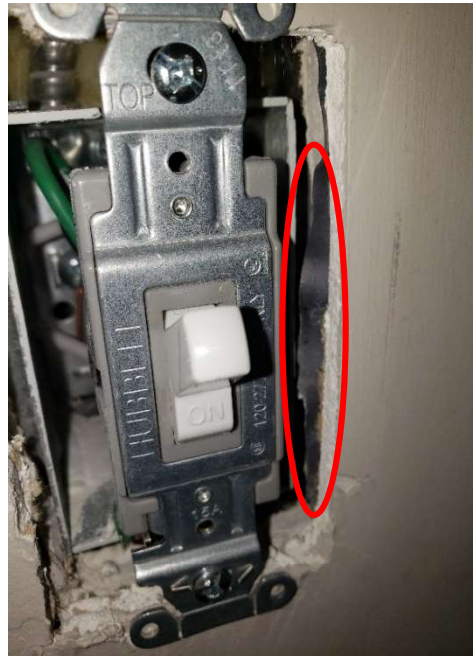
Lead sheeting was observed behind drywall surfaces in the west and east partition walls in all four Operation Rooms and the western Corridor in the Oral Health Clinic as outlined within the attached Site plan. Additional lead sheeting may be present in other concealed locations. Additionally, lead is suspected within lead aprons, solder in domestic water pipes and in the lead acid batteries of emergency lighting. Bulk-lead materials should be extracted and sent to a recycling facility. If recycling of the lead is not practicable then it must be disposed of in an approved landfill as lead waste.

**Photograph 1: Lead sheeting concealed behind drywall surfaces in the west and east partition walls in all four Operation Rooms and western Corridor located in the Oral Health Clinic.**

The potential for worker exposure to lead dust and fumes is dependent on how the materials are to be disturbed. The Ministry of Labour (MOL) [Guideline - Lead on Construction Projects](#) (updated April 2011) should be consulted prior to completing a specific task with the objective of evaluating the need for health and safety precautions such as engineering controls, safe work and hygiene practices, personal protective equipment and training.

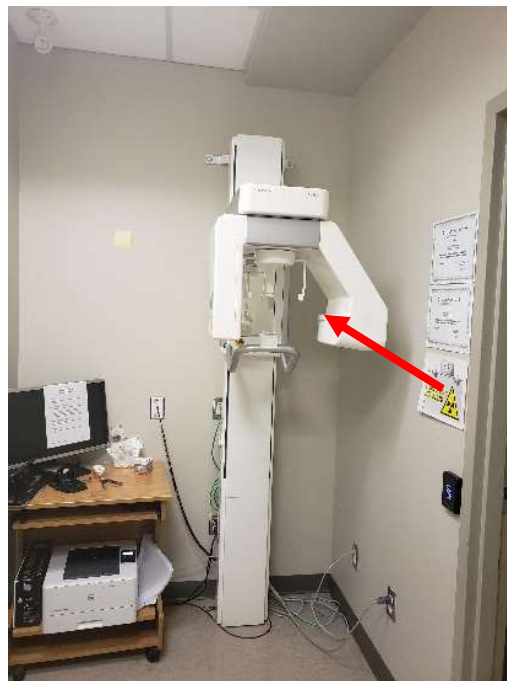
Dental X-Ray machines were observed in the four Operation Rooms and the western Corridor in the Oral Health Clinic. X-Ray machines may contain harmful materials such as Lead, Cobalt 60, beryllium and other hazardous

waste metals may be contained within the device. If not reused, the X-Ray units should be sent to a licensed hazardous waste facility.

**Photograph 2: X-Ray cameras observed in Operation Rooms and western Corridor, located in the Oral Health Clinic.**

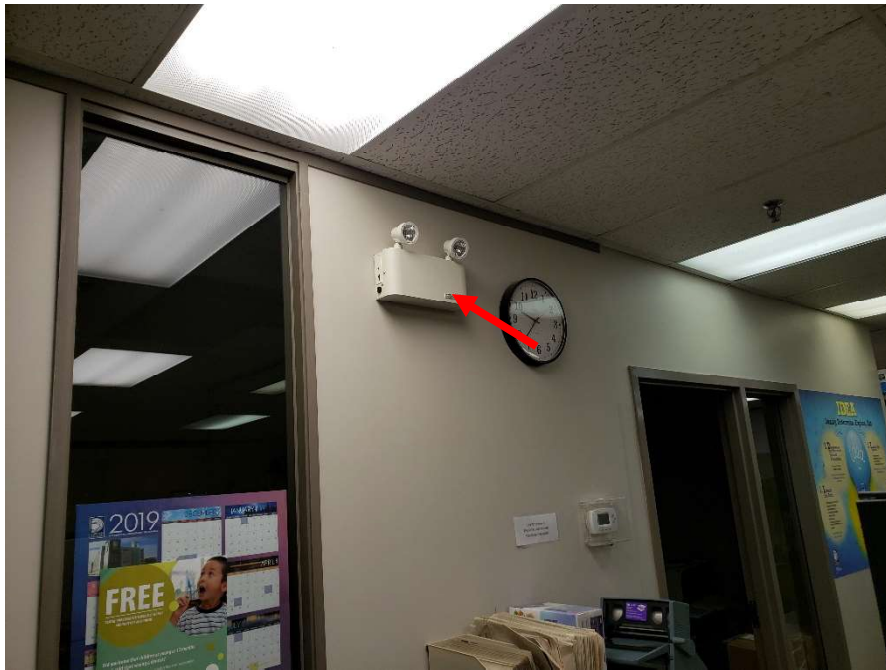
**Photograph 3: Presumed lead-containing batteries within emergency lighting.**

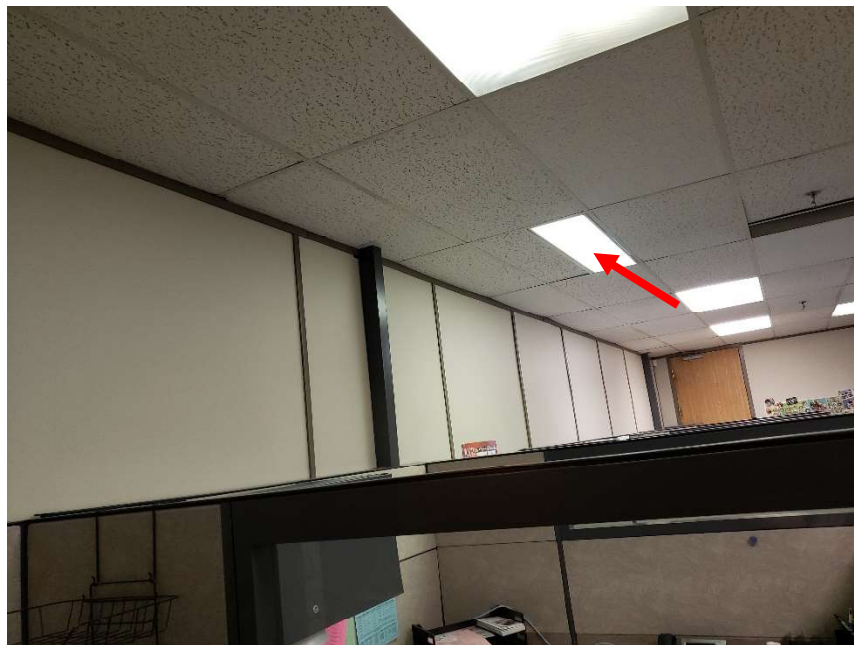
Mercury is suspected in small amounts within fluorescent light tubes throughout the Oral Health Clinic and Oral Health Administration Office. Materials suspected to contain mercury that are to be disturbed during future renovation should be re-used or recycled. If recycling is not practicable then dispose of as mercury containing waste.

**Photograph 4: Suspected mercury within light tubes throughout the Oral Health Administration Office.**
