August 31, 2020

Project No. 20147153(2000)

**PRE-RENOVATION DESIGNATED SUBSTANCES AND HAZERDOUS MATERIALS ASSESSMENT SURVEY
– 200 JOHN STREET WEST, UNIT 5C, OSHAWA, ONTARIO**

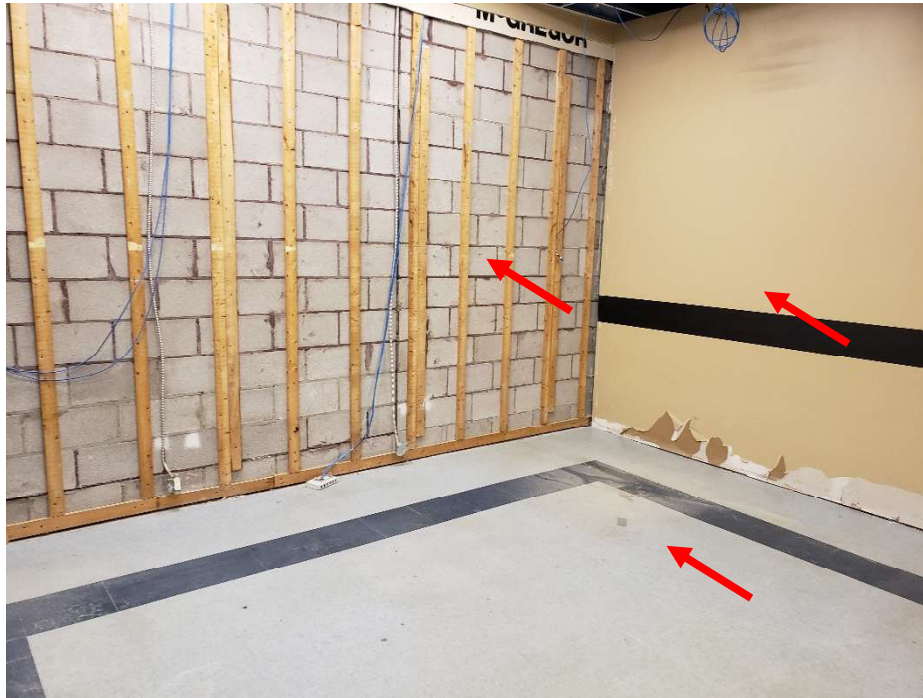
- Drywall joint compound throughout the Unit (Samples 01A-E);
- Joint compound on drywall ceilings in the Men's and Women's Washrooms (Samples 02A-C);
- Dark blue 12"x12" vinyl floor tiles with associated black mastic throughout the former Classrooms (Samples 03A-C, layer 1 and 2);

- Light blue 12"x12" vinyl floor tiles with associated black mastic found throughout former Classrooms (Samples 04A-C, layer 1 and 2);
- Light blue speckled 12"x12" vinyl floor tiles with associated black mastic found throughout the Boiler and Electrical Rooms (Samples 05A-C, layer 1 and 2);

- Purple tinted interior concrete brick mortar found on the south-east walls (Samples 06A-C);
- Interior concrete brick mortar found on the north-east walls (Samples 07A-C);

Photograph 1: Non-asbestos various 12"x12" vinyl floor tiles, drywall joint compound, and concrete brick mortar within former Classrooms, throughout Unit.

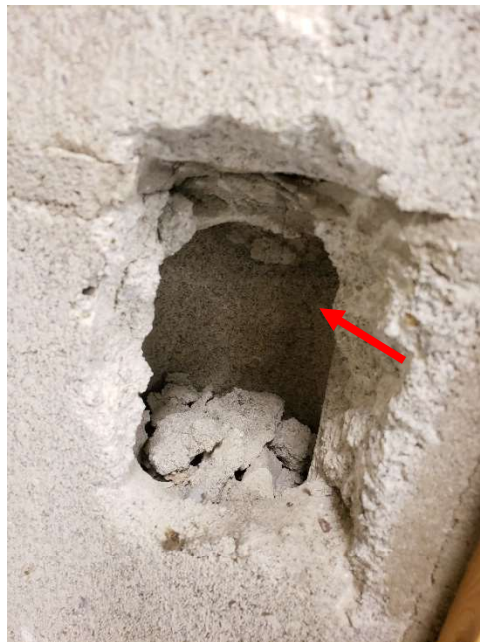
Bell and spigot cast iron pipe connections were not observed. In addition, no vermiculite insulation was observed in the north-east concrete block wall, however it may be present in concealed locations not investigated. Additionally, the rooftop and HVAC systems were not within the renovation scope of work and was not investigated.

Photograph 2: Where observed, no vermiculite present within concrete block walls.

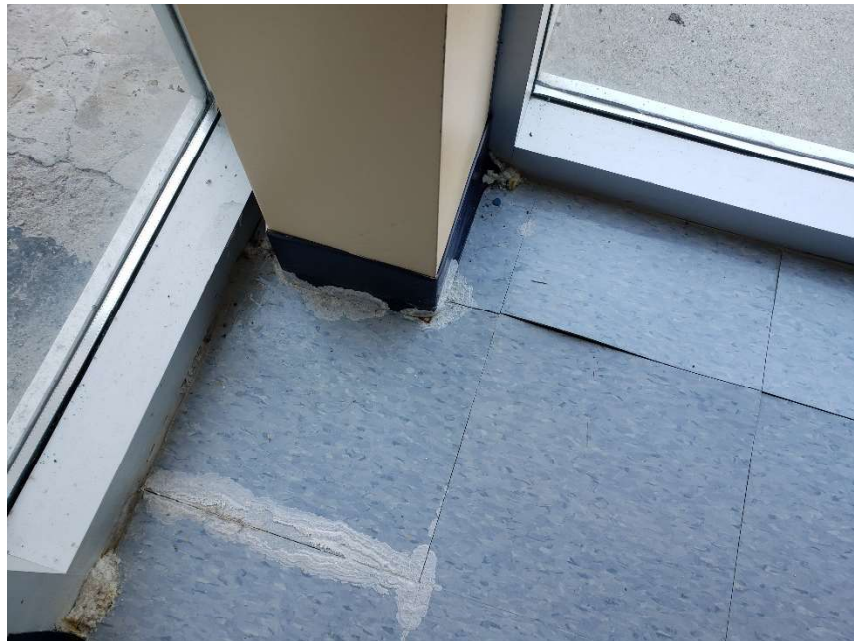
Approximately five square feet of water-damage was present on the west windowsills, drywall walls and non-asbestos vinyl floor tiles in former Classroom 5 and Classroom 6. Additionally, approximately 15 water-damaged acoustic ceiling tiles were observed throughout the Unit. Visible mould was not identified during the assessment; however the water damage could be an indication of concealed mould growth behind drywall surfaces. As a precautionary measure the ceiling tiles should be disposed of following Level 1 procedures as defined under the Environmental Abatement Council of Ontario (EACO) *Mould Abatement Guidelines, Edition 3 (2015)* (the EACO Guidelines). It is also recommended that a building science engineer determine the water sources with the goal of providing suitable repair options.

Photograph 4: Water-damaged non-asbestos vinyl floor tiles and drywall.

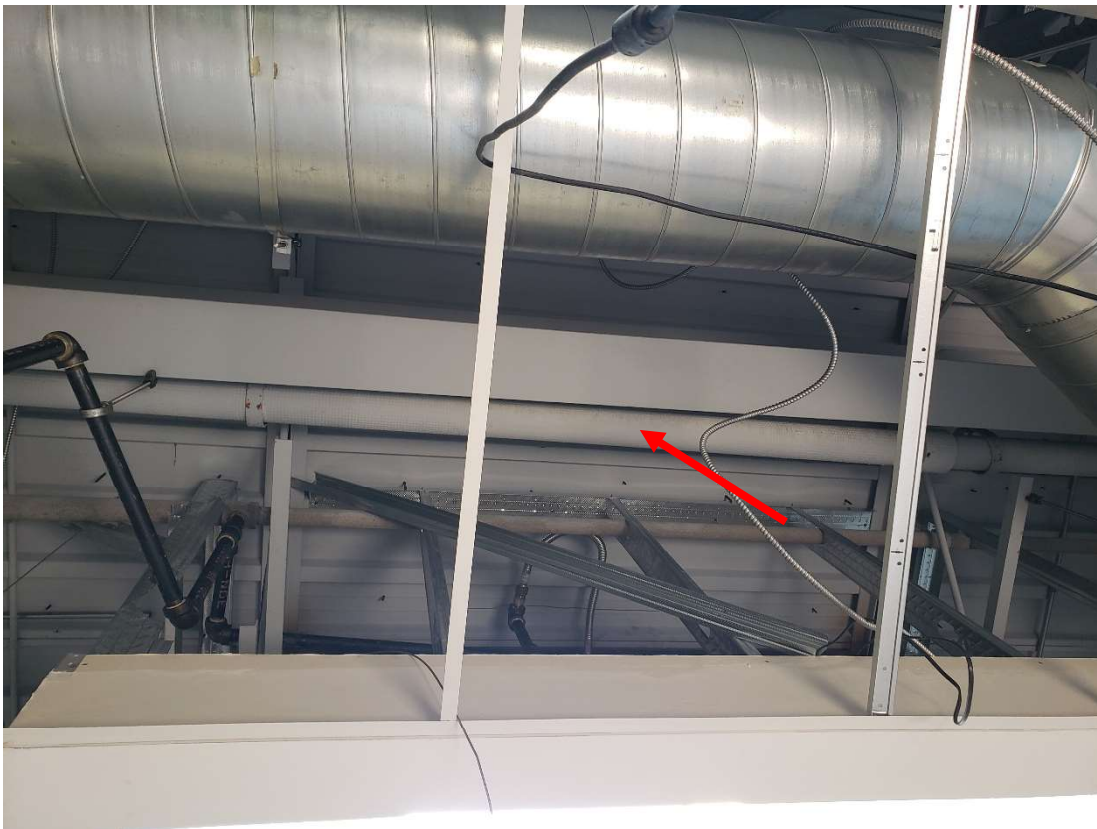
Photograph 6: Asbestos-cement (also known by the tradename Transite™) observed in the traversing ceiling space throughout the Unit.

- Approximately 100 linear feet of presumed asbestos-cement (also known by the tradename Transite™) pipe was observed in the traversing ceiling space throughout the Unit. If the non-friable asbestos-cement pipe is to be impacted during future renovation or maintenance activities, the piping should be removed following Type 1 asbestos procedures, as prescribed under O. Reg. 278/05, provided the pipe remains wetted throughout the removal process and only non-powered hand tools are used. If powered tools are used to remove the pipe, then Type 2 or 3 asbestos procedures are required, dependant on the tools used.
