Designated Substances Survey Report

St. Alban's Church

567 Monaghan Road
Peterborough, Ontario
K9J 5H8

Project Number: I250114A

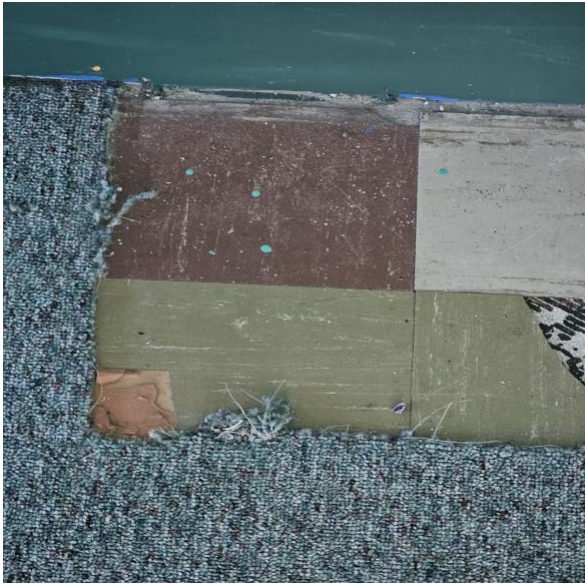
Photograph 1 – Basement
Asbestos tile beneath the carpet.

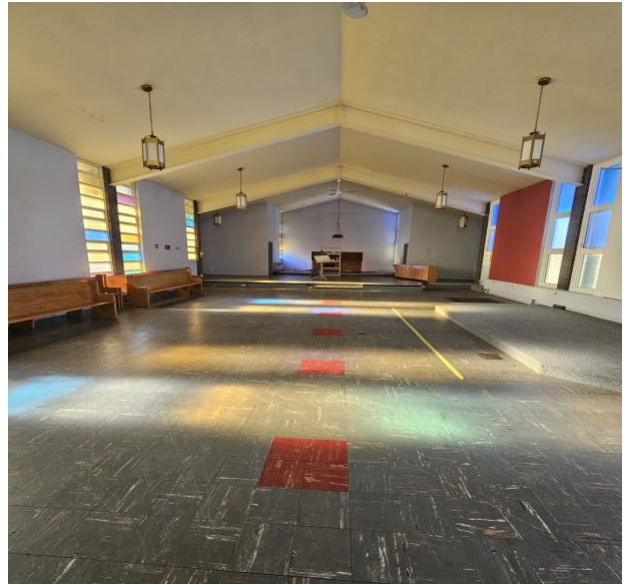
Vinyl floor tiles (9x9) observed throughout the building were sampled and analyzed for asbestos content using the PLM method of detection. Samples submitted were found to contain *Chrysotile* asbestos. Please refer to Sample Sets 10, 11, 12, 13 & 14 within Table 3 and Appendix IV for further details.

Photograph 2 – Nave
Asbestos Floor Tile (9x9)

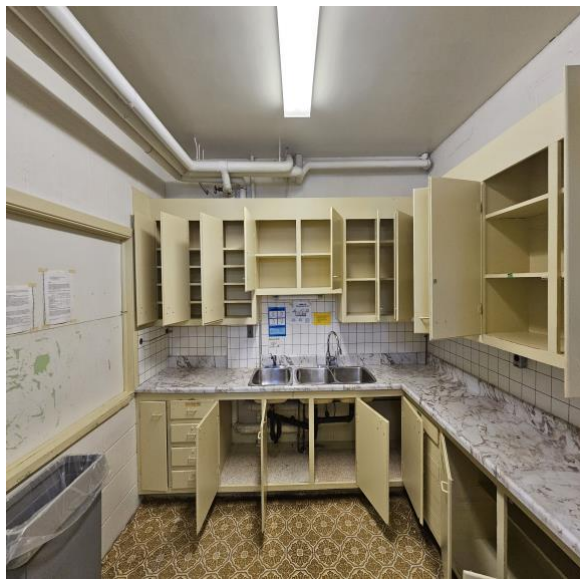
A single sample of asbestos paper-fitting which was observed within the Kitchen was collected and analyzed for asbestos content using the PLM method of detection for confirmatory purposes. The sample submitted was confirmed to contain **Chrysotile** asbestos. Please refer to Sample Set 3, within Table 3 and Appendix IV for further details.

Photograph 3 – Photo of asbestos pipe insulation in kitchen
(and cabinets).

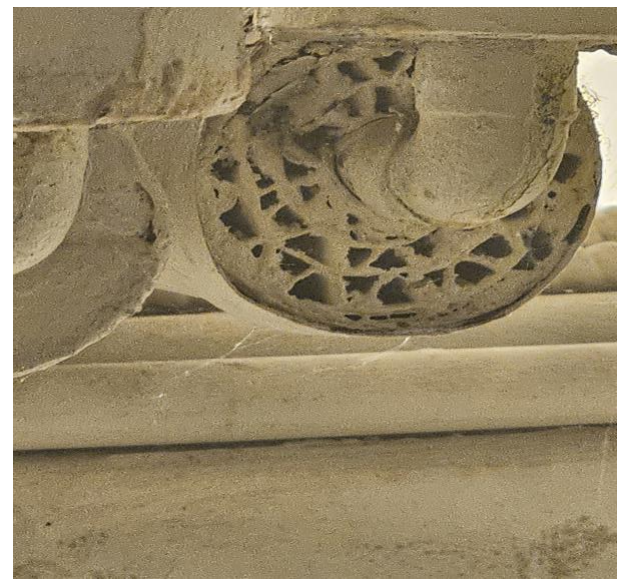
Photograph 4 – Photo of Asbestos Air Cell
Insulation.
