**S2S**  
Environmental Inc.

# Designated Substances Survey

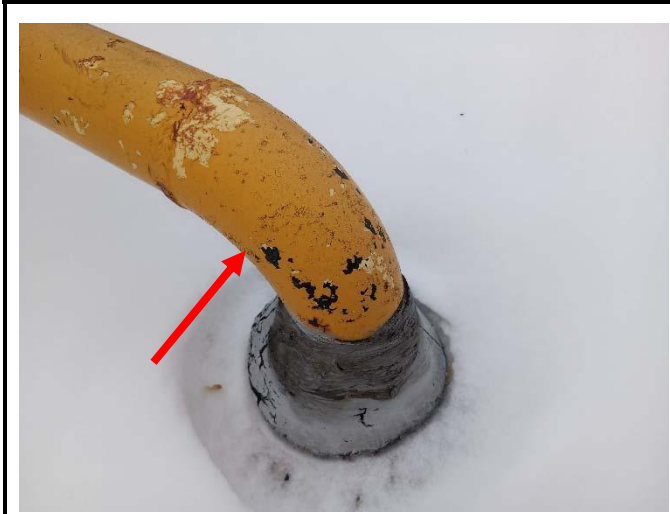
**Photo 1:** View of the lead containing yellow paint (see arrow) observed to be in fair condition on the metal roof piping.

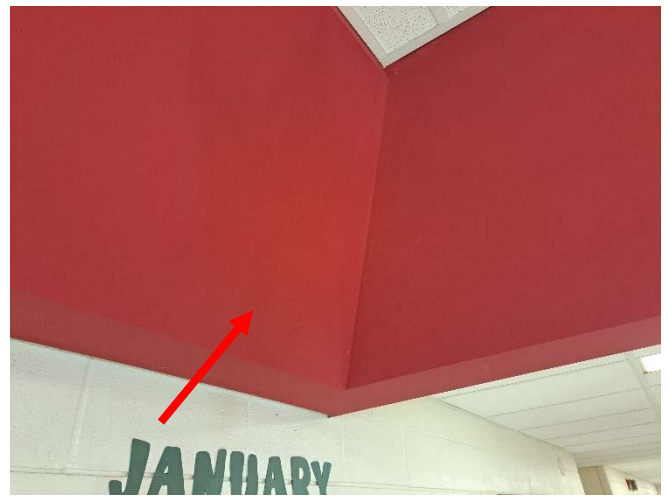
**Photo 2:** View of the lead containing red paint (see arrow) observed to be in good condition on the bulkhead in the Main Foyer.

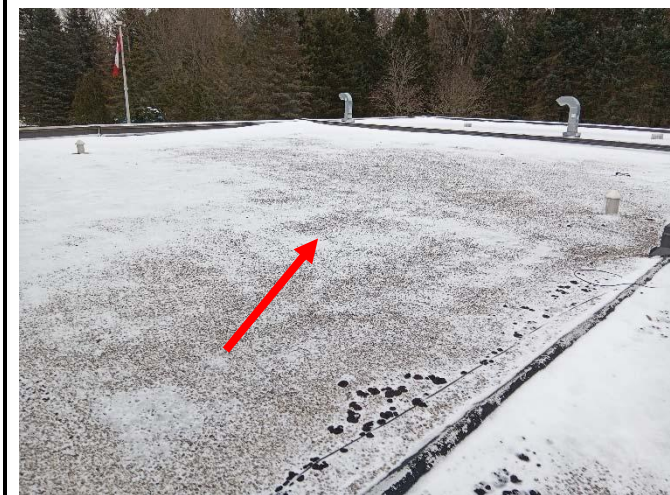
**Photo 3:** View of the presumed asbestos containing built-up roofing (see arrow) observed on the Roof of the Subject Building.

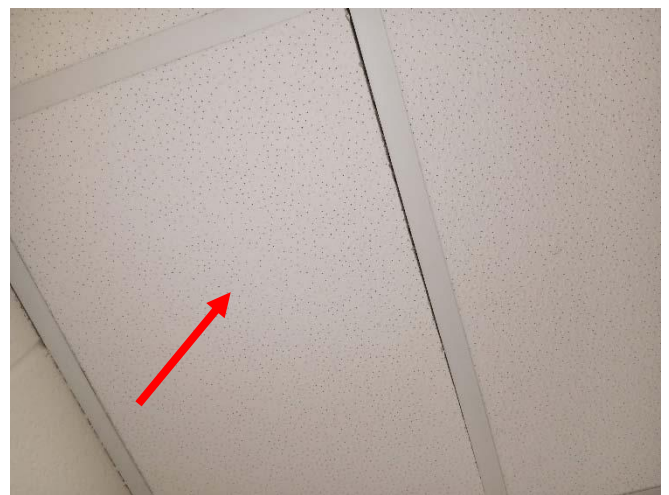
**Photo 4:** View of the non-asbestos containing white 4' x 2' textured acoustic ceiling tiles with pinholes (see arrow) observed within the Corridor 107 near the Main Foyer.

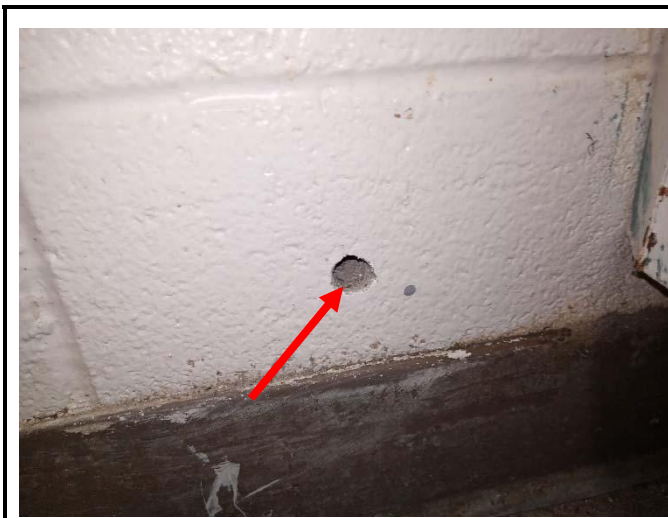
**Photo 5: View of opening drilled in concrete block wall (see arrow) of Custodian Room 130 with the Subject Building for vermiculite investigation.**

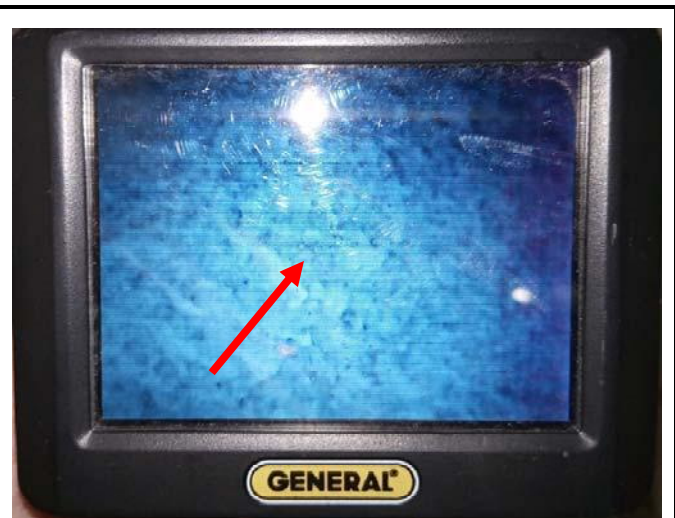
**Photo 6: View of exterior facing wall cavity (see arrow) observed with a borescope indicating no presence of vermiculite within Custodian Room 130 of the Subject Building.**

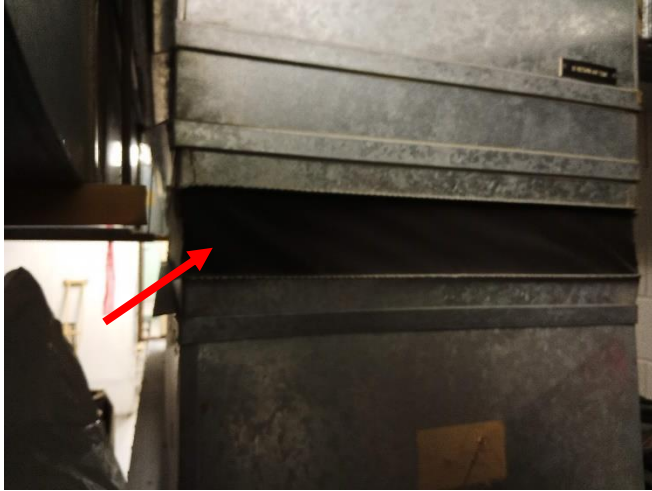
**Photo 1:** View of presumed asbestos containing vibration dampers (see arrow) observed to be in good condition within Boiler Room 141.

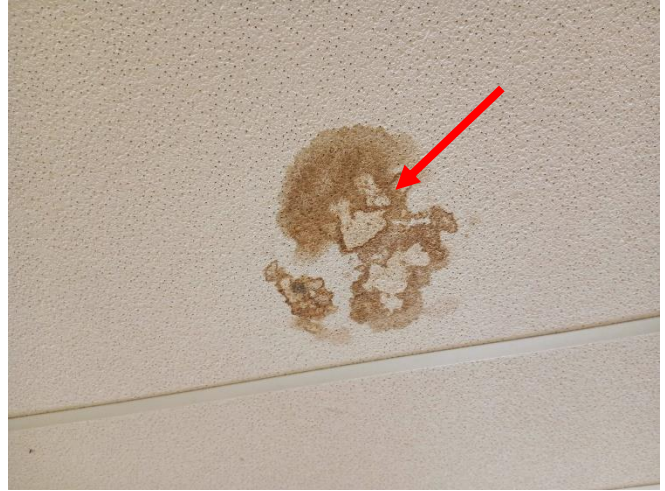
**Photo 2:** View of the visual suspected mould growth (see arrow) observed on lay-in acoustic ceiling tiles within Corridor 159A.

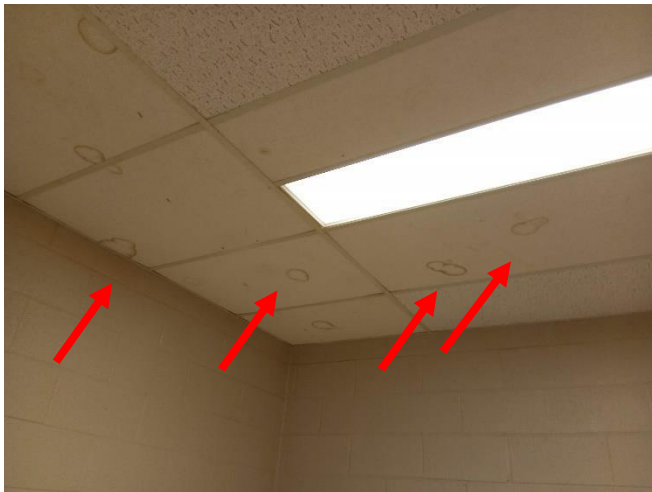
**Photo 3:** View of the apparent water stains (see arrows) observed on six lay-in acoustic ceiling tiles within the Boy's Changeroom 138.

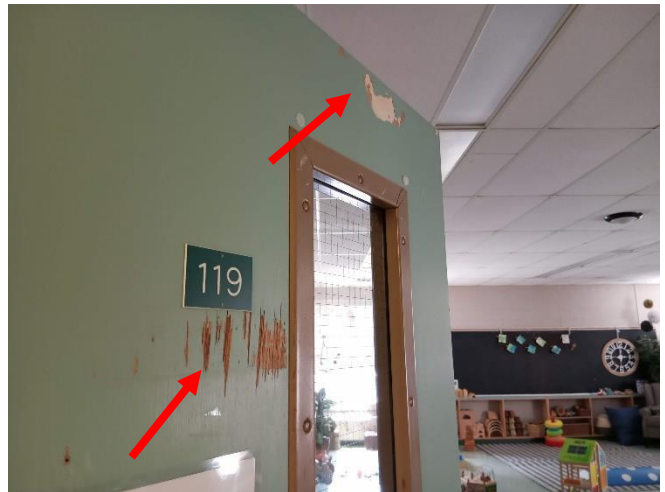
**Photo 4:** View of the lead containing light green paint (see arrows) observed to be in fair condition on the door of Art Room 119.
