**S2S**  
Environmental Inc.

# Designated Substances Survey

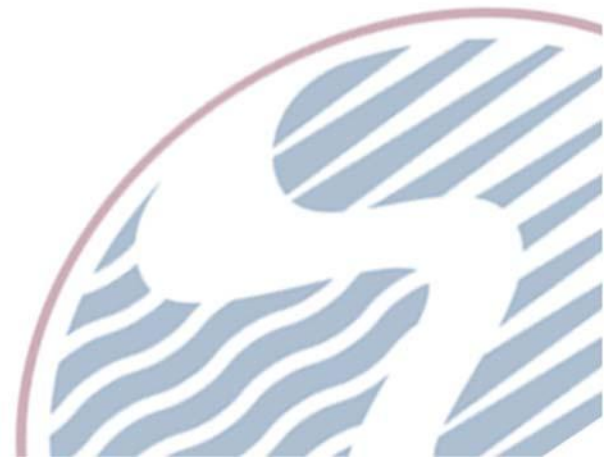
## TABLE OF CONTENTS

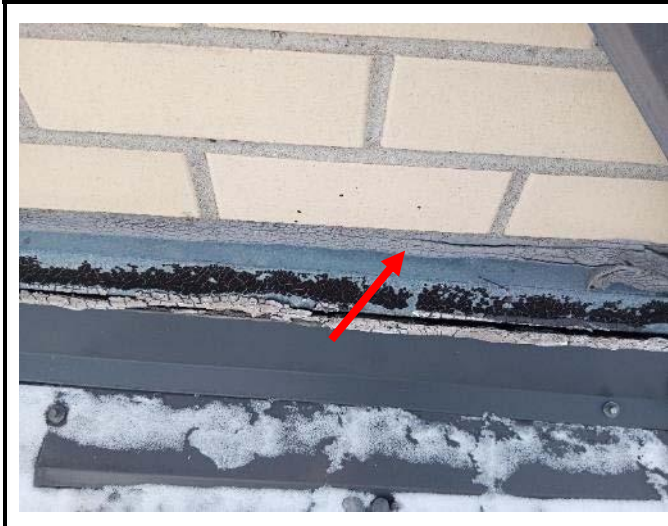
**Photo 1:** View of the asbestos containing grey caulking (see arrow) observed to be in poor to fair condition on the Roof Flashings of the Foyer Roof.

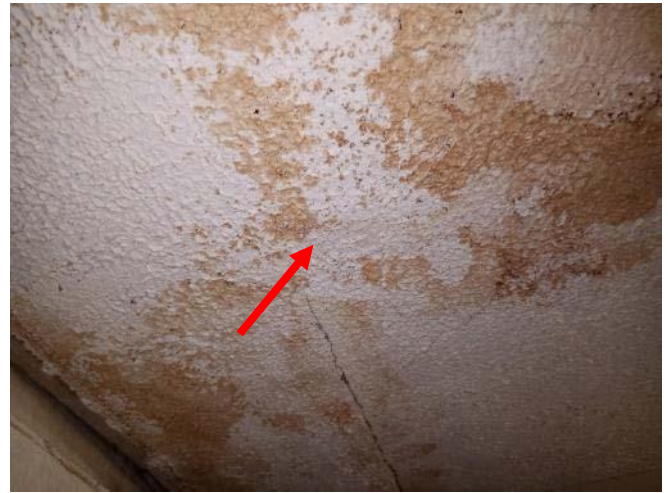
**Photo 2:** View of the ceiling finishes with associated non-asbestos containing white compound (see arrow) observed to be water-stained in Custodial Room 147 within the Subject Building.

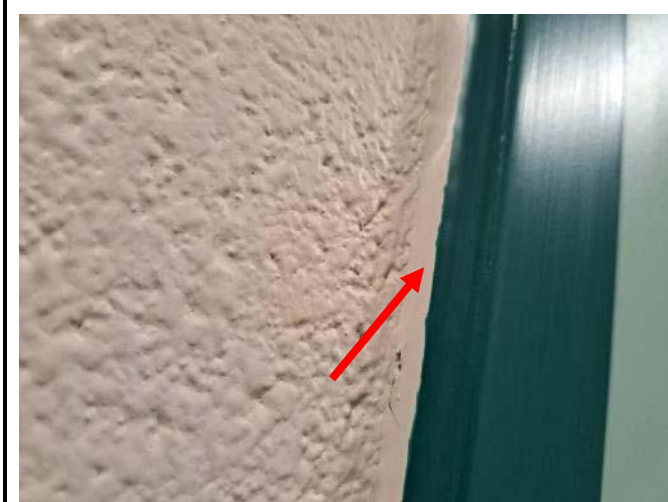
**Photo 3:** View of the asbestos containing beige caulking (see arrow) observed to be in good condition on the door frames within Rooms 108 and 109 of the Subject Building.

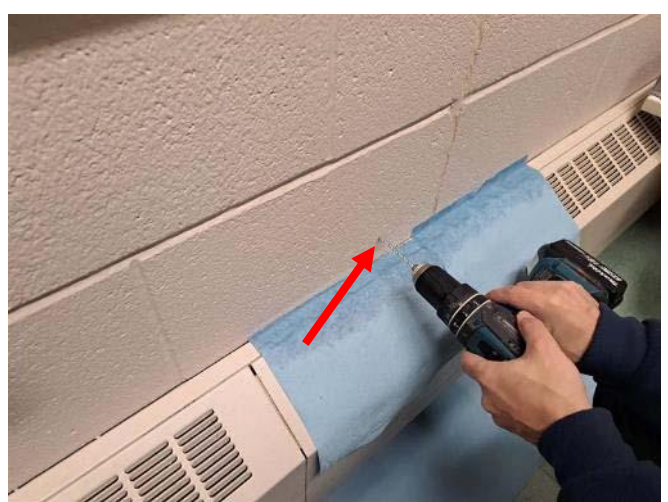
**Photo 4:** View of the interior wall during the vermiculite investigation and drilling activities prior to repair patching (see arrow) within Room 109 of the Subject Building.

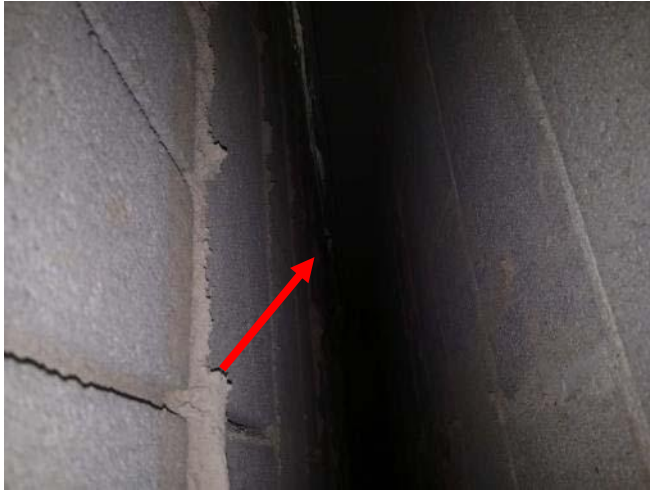
**Photo 5:** View of the void wall cavity (see arrow) observed during the vermiculite investigation between Room 108 and Room 109 of the Subject Building.

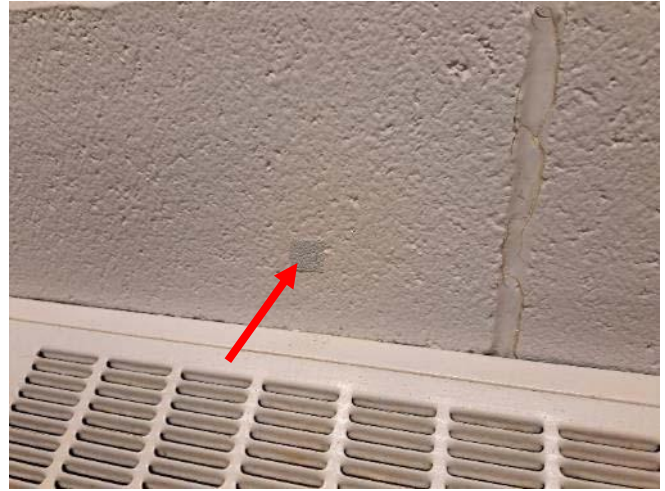
**Photo 6:** View of the interior wall post vermiculite investigation and drilling/ patching activities (see arrow) within Room 109 of the Subject Building.

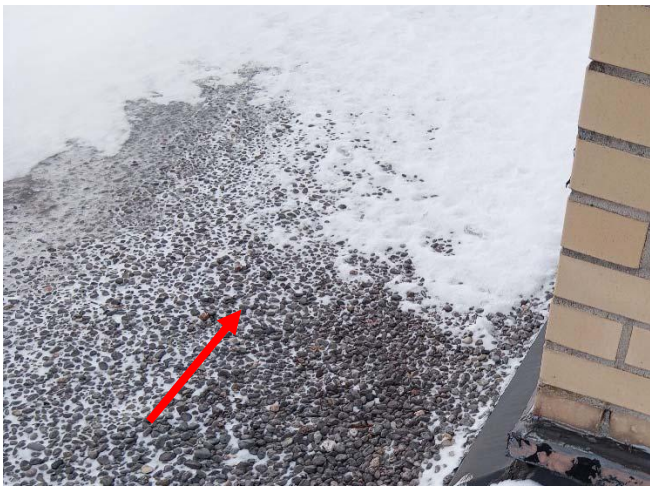
**Photo 7:** A view of the built-up roofing system (see arrow) observed throughout the Roof of the Subject building.

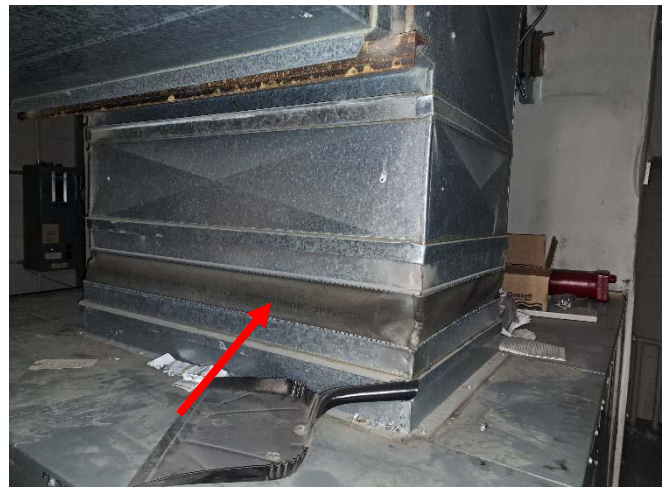
**Photo 8:** View of a presumed asbestos containing vibration dampener in Mechanical Room 201 within the Subject Building.

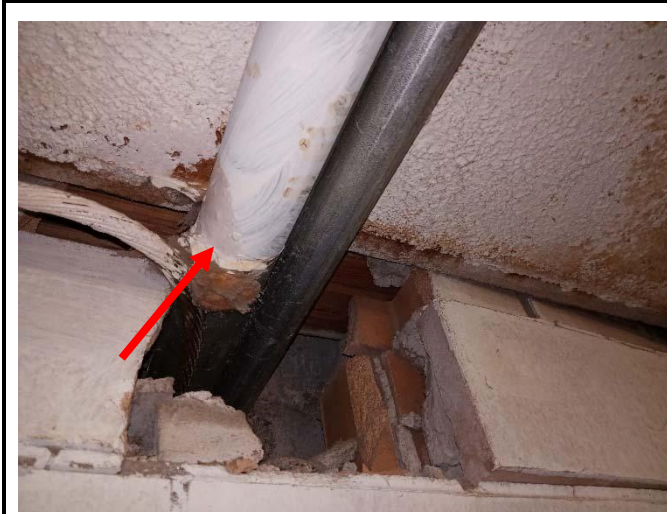
**Photo 9:** View of non-asbestos containing fibreglass pipe insulation (see arrow) observed in Custodial Room 147 within the Subject Building.

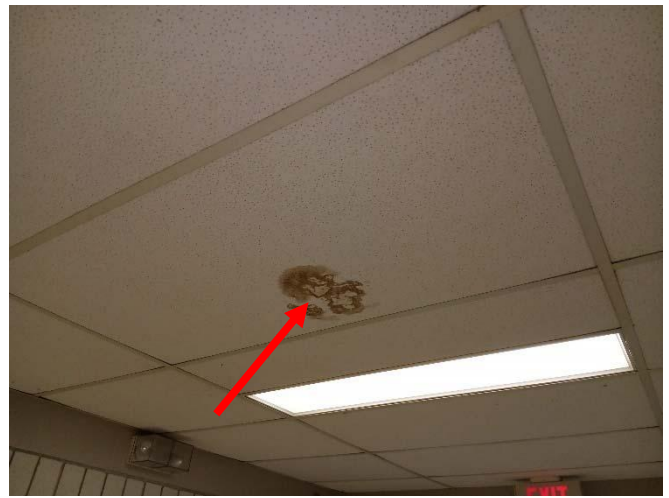
**Photo 10:** A view of water-staining and suspect mould (see arrow) observed on non-asbestos containing acoustic ceiling tile in Corridor 172 within the Subject Building.

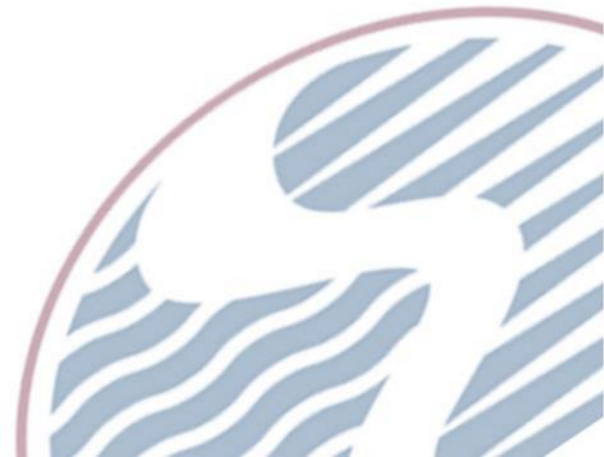
## TABLE OF CONTENTS

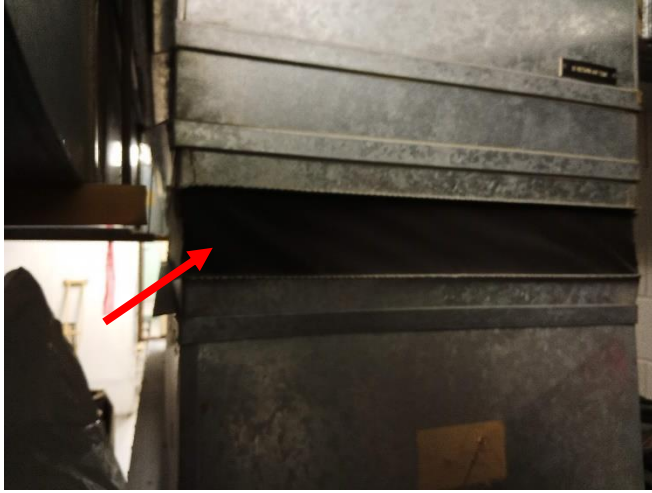
**Photo 1:** View of presumed asbestos containing vibration dampers (see arrow) observed to be in good condition within Boiler Room 141.

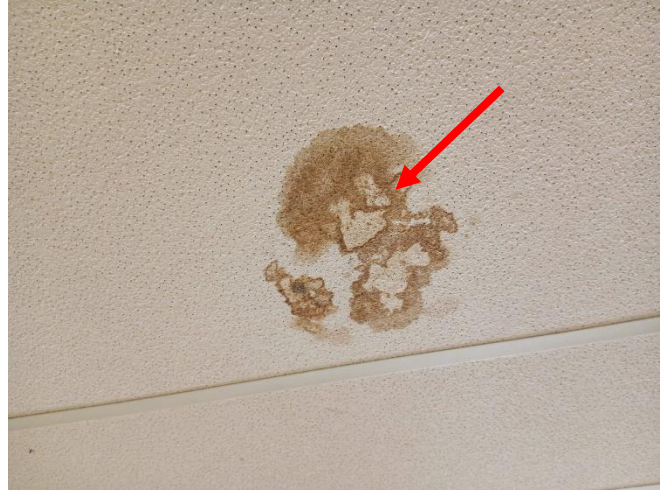
**Photo 2:** View of the visual suspected mould growth (see arrow) observed on lay-in acoustic ceiling tiles within Corridor 159A.
