Phase Two Environmental Site Assessment

900 Mulock Drive
Newmarket, Ontario

DS Project No: 19-190-100

Date: 2019-12-23

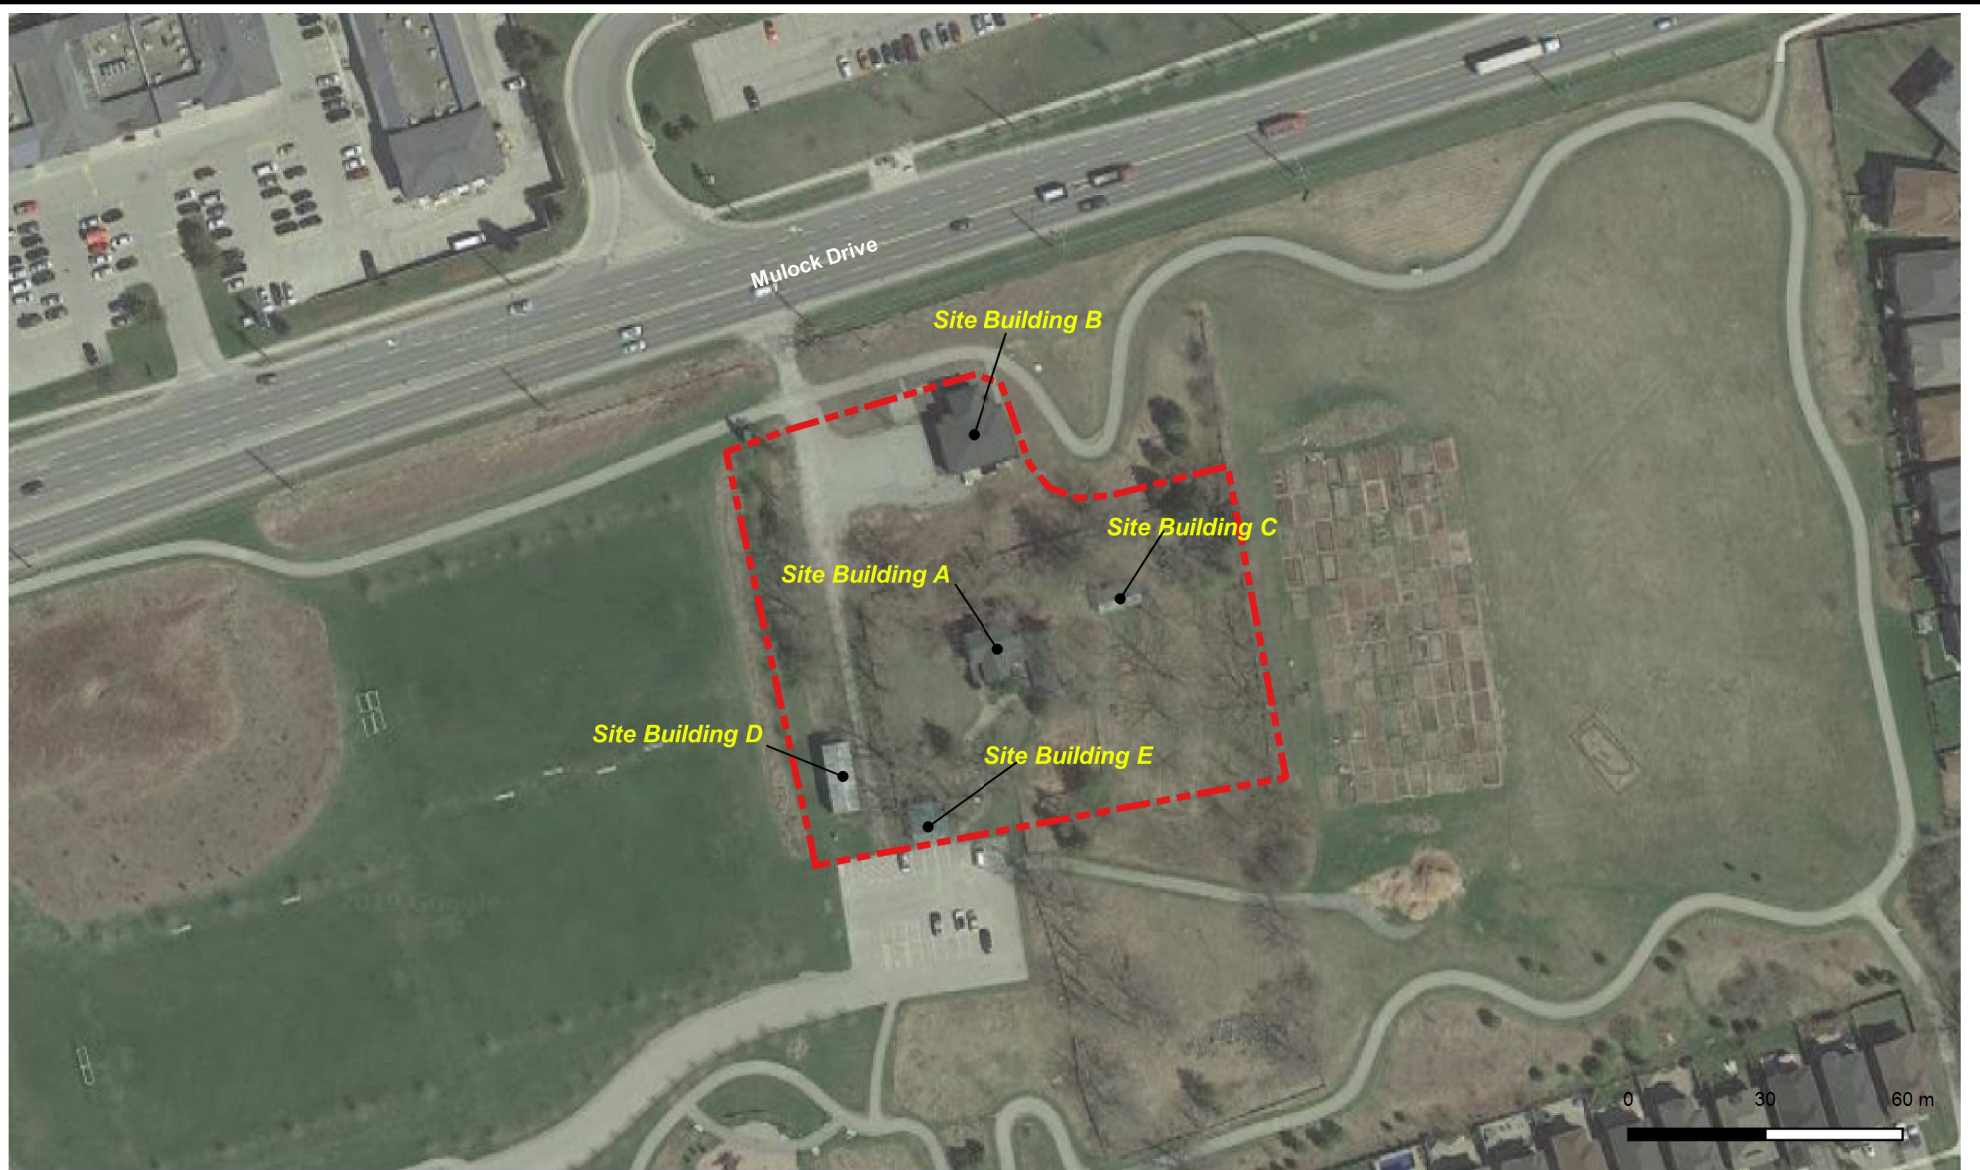
Figure No.: **2**

Figure 2 – Phase Two Property Site Plan

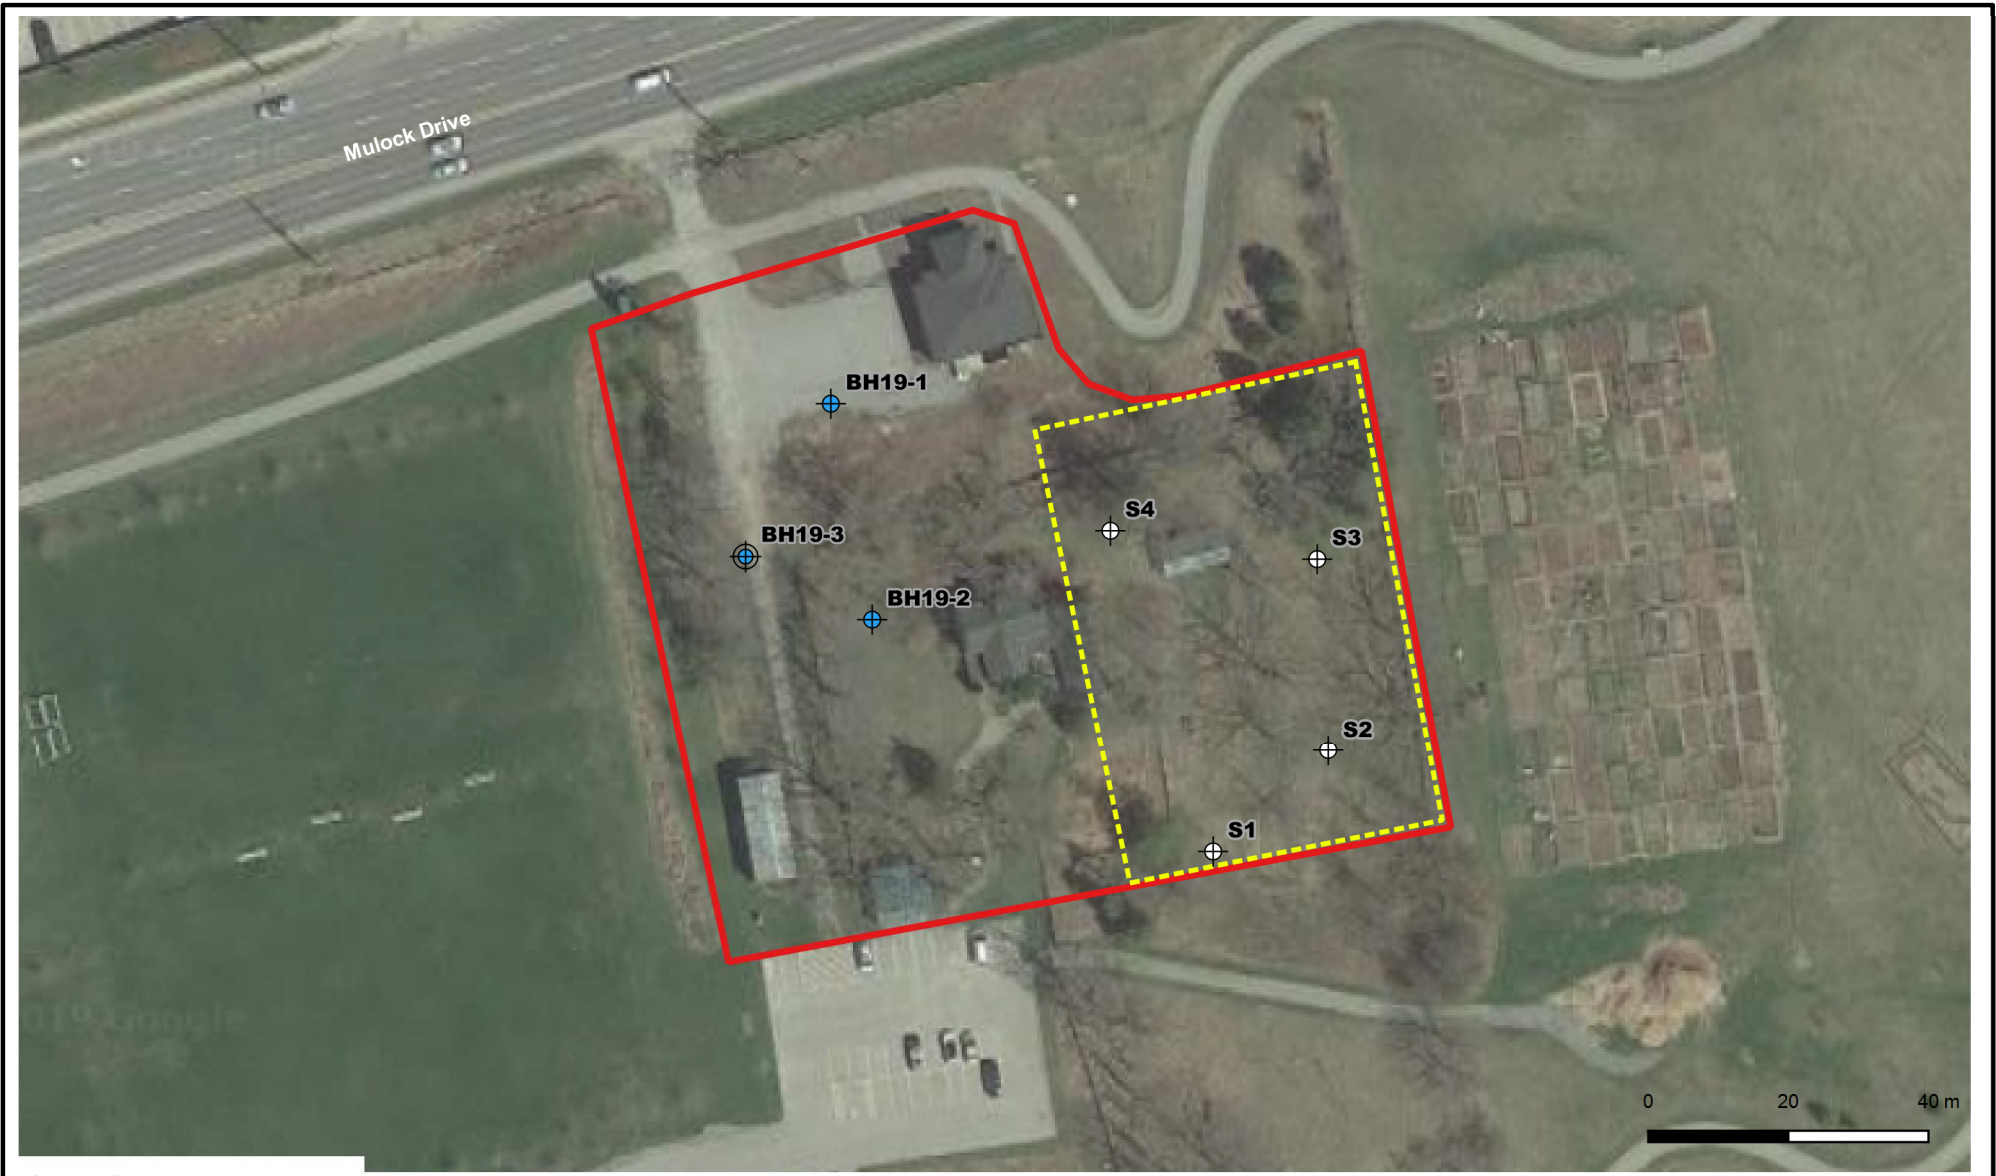
- Approx Property Boundary
- + Hand Augered Borehole
- + Borehole
- + Monitoring Well
- APEC 1

Title: BOREHOLE LOCATION PLAN WITH APECs			
Client: COUNTERPOINT ENGINEERING c/o DENISON CHILD CARE SERVICES – YRDSB	Size: 8.5 x 11 Rev: 0	Approved By: D.D Scale: As Shown Image/Map Source: Google Satellite Image	Drawn By: S.Y Project No.: 19-190-100	Date: December 2019 Figure No.: 5

The Phase Two ESA involved the advancement of four (4) shallow hand auger boreholes (up to 0.6 mbgs), which were completed on November 22, 2019. Additionally, Geotechnical and Hydrogeological investigations were conducted on October 17, 2019, involving the completion of three (3) boreholes with one (1) monitoring well installation. The boreholes were advanced to a maximum depth of 8.1 metres below ground surface (mbgs) under the supervision of DS personnel. The hand auger borehole locations were determined based on the findings of the Phase One ESA. Soil samples were collected and submitted for analysis of all PCOCs, including: Metals, Hydrides, Cyanide, and OCPs.

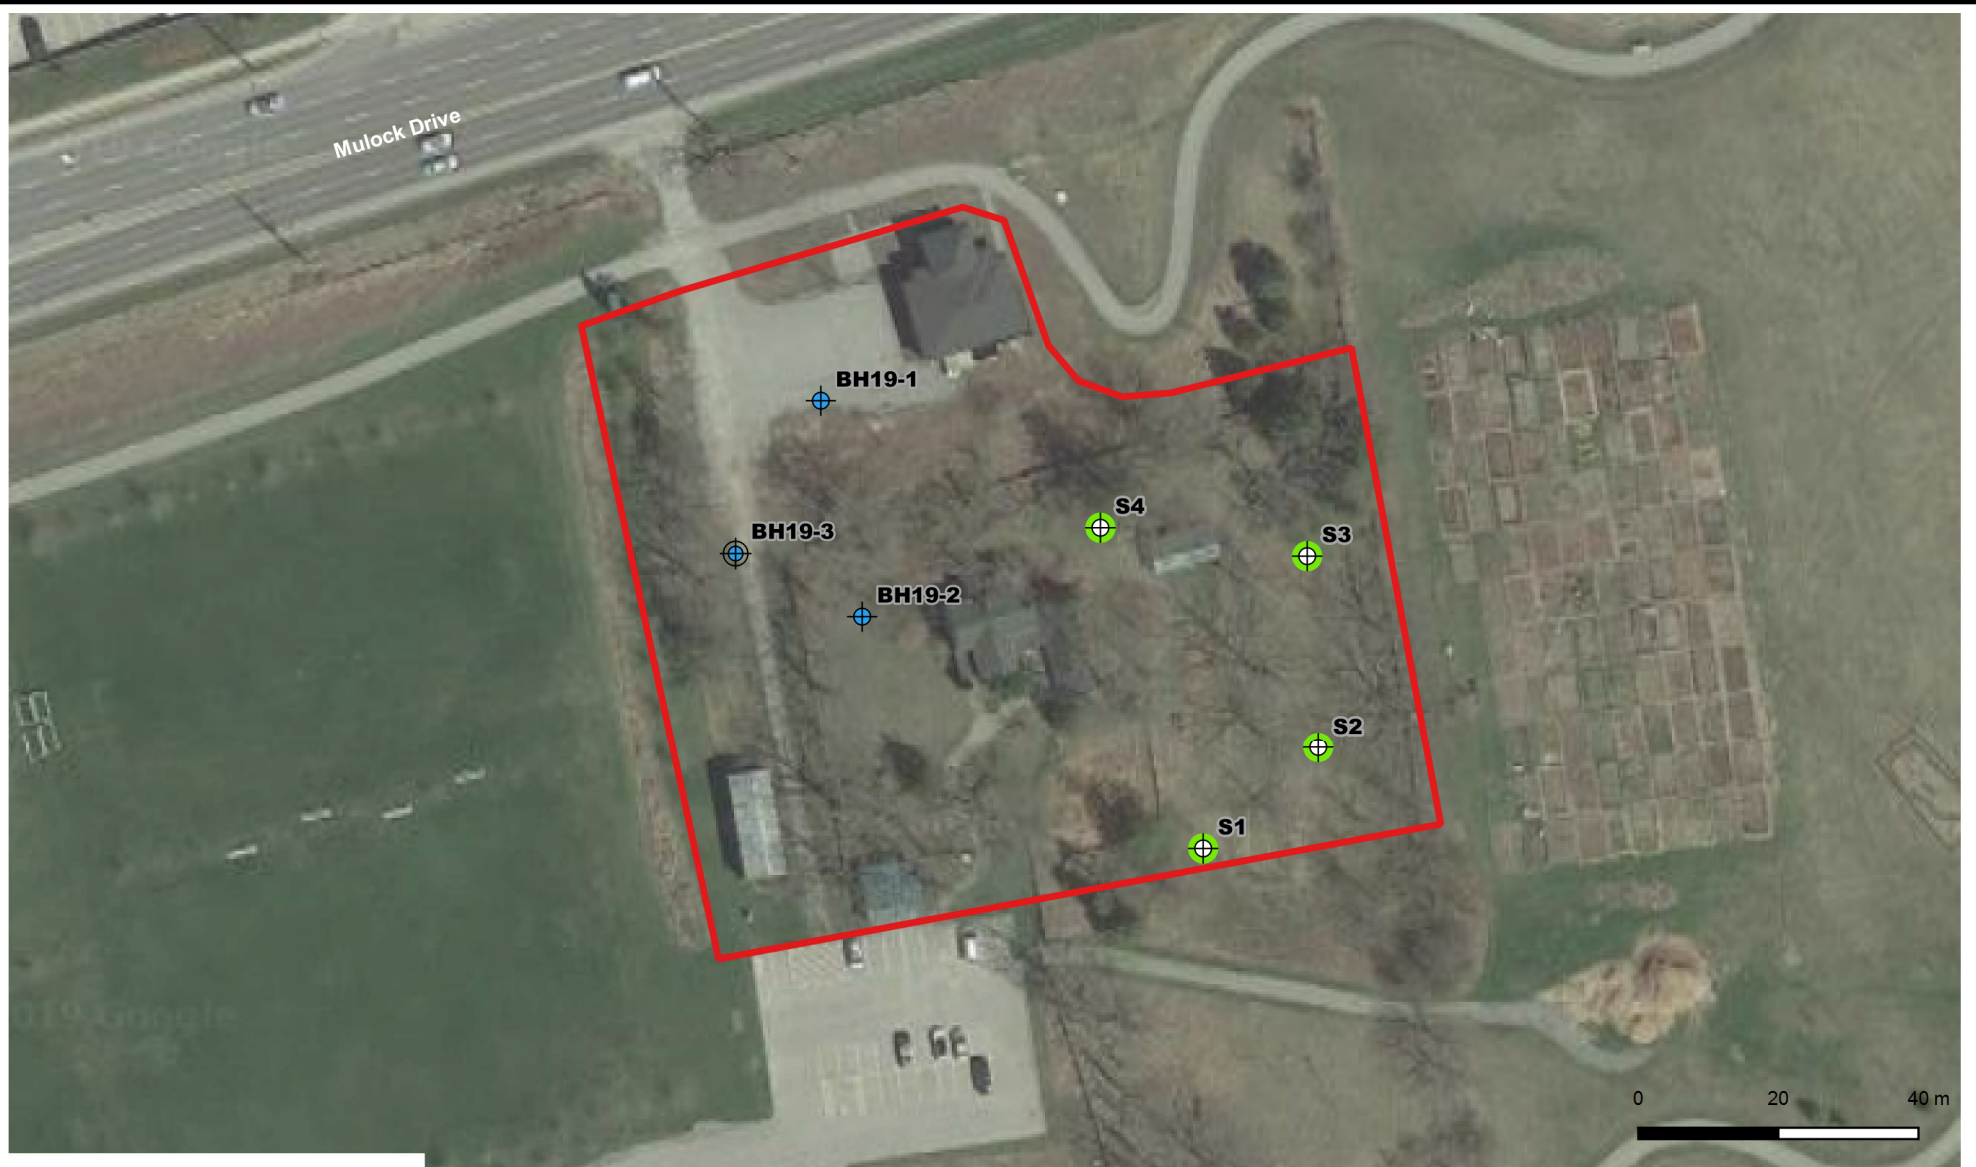
- Approx Property Boundary
- ⊕ Hand Augered Borehole
- ⊗ Borehole
- ⊕ Monitoring Well
- Sample Met Applicable Standards

Title: SUMMARY OF METALS, HYDRIDES AND CYANIDE IN SOIL			
Client: COUNTERPOINT ENGINEERING c/o DENISON CHILD CARE SERVICES – YRDSB	Size: 8.5 x 11 Rev: 0	Approved By: D.D Scale: As Shown Image/Map Source: Google Satellite Image	Drawn By: S.Y Project No.: 19-190-100	Date: December 2019 Figure No.: 6A

- ◆ Soil samples were collected from four (4) hand auger boreholes advanced on the Phase Two Property and submitted for analysis of metals, hydride forming metals, cyanide and OCPs. The results of the chemical analyses conducted indicated that all samples analyzed met the applicable Site Condition Standards.

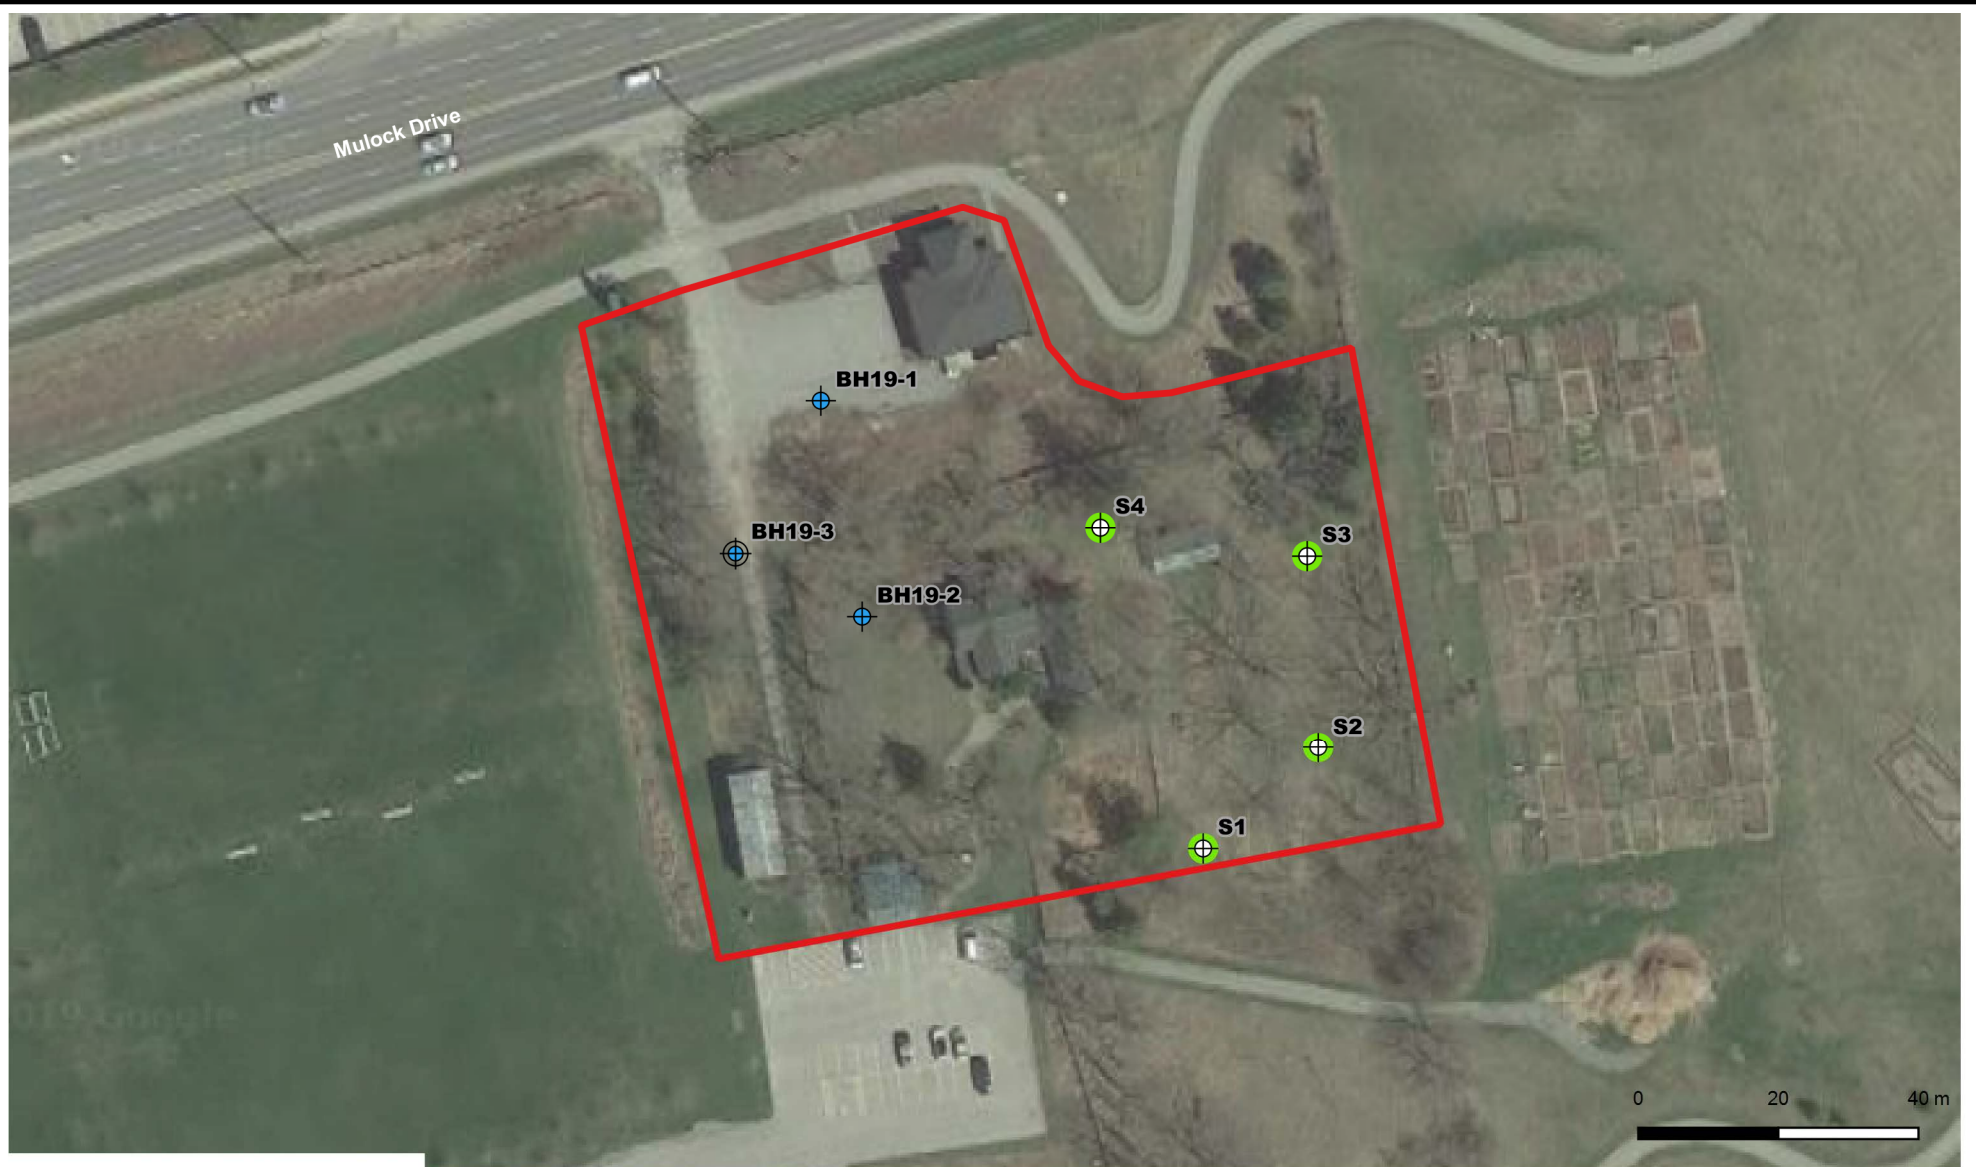
Figure 6B – Summary of ORPs in Soil

- Approx Property Boundary
- ⊕ Hand Augered Borehole
- ⊗ Borehole
- ⊕ Monitoring Well
- Sample Met Applicable Standards
