# SITE SERVICING AND STORMWATER MANAGEMENT BRIEF IN SUPPORT OF SITE PLAN APPROVAL

**Dr. John M. Denison Child Care Centre**  
900 Mulock Drive/ 605 Fernbank Road  
Newmarket, ON

**Prepared For:**  
**Larkin Land Use Planners**

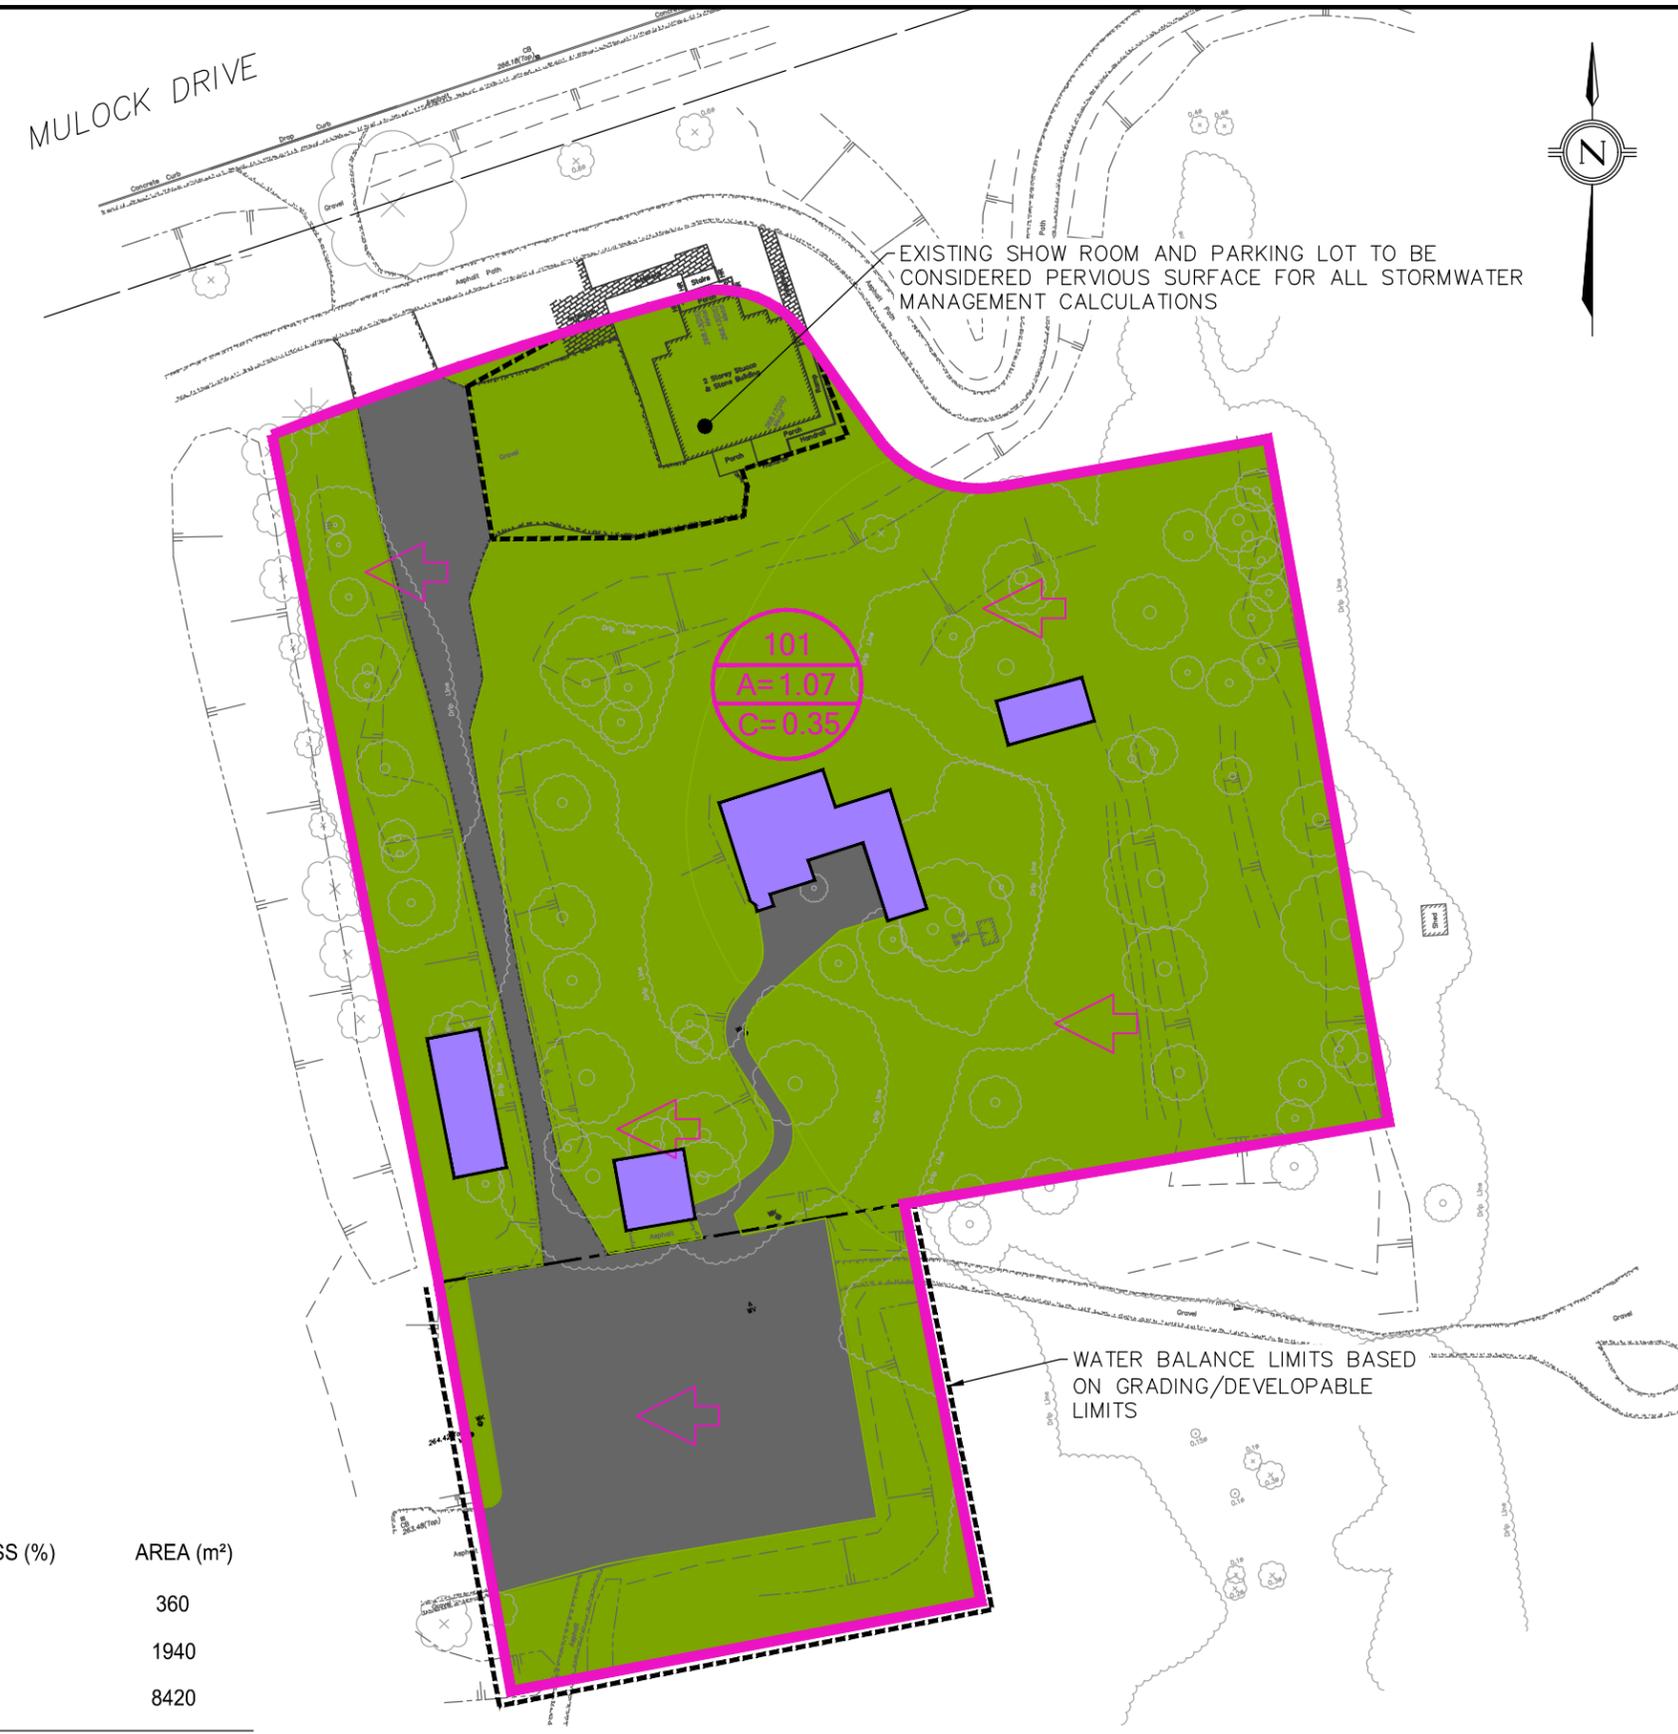
DESIGNED BY: ES	DATE: MAR 2020
CHECKED BY: CB	PROJECT No. 19055
DRAWING BY: ES	
CHECKED BY: CB	FIGURE No. 1
SCALE: 1:750

EXISTING SHOW ROOM AND PARKING LOT TO BE CONSIDERED PERVIOUS SURFACE FOR ALL STORMWATER MANAGEMENT CALCULATIONS

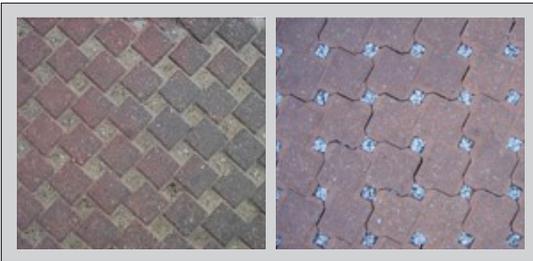
### 5. Covered Joint Material:

- Identify problem and correct.
- Remove immediately.
- Joint material should appear as photo on right.

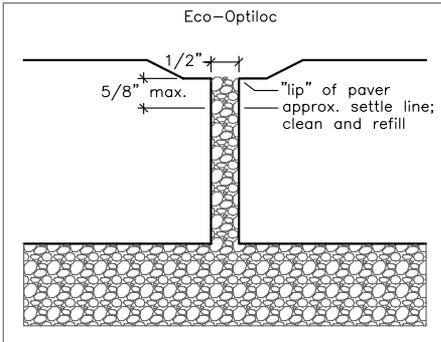
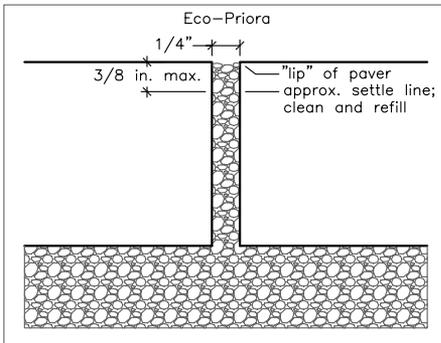
- 1. Preventative** – removes most miscellaneous debris before being trapped in the joint aggregate material causing clogging. This usually does not require removal of any joint material to restore infiltration.
- 2. Restorative** – requires some removal or complete removal of the joint material to renew infiltration. Occurs after miscellaneous debris has been captured and lodged in the joint aggregate.

**\*Note:** Both maintenance types will be most effective when the joint aggregate material is filled to the "lip" of the paver. If the joint material has settled more than the joint width, plus 1/8 inch below the paver lip, the maintenance equipment is significantly less effective and potentially more expensive.

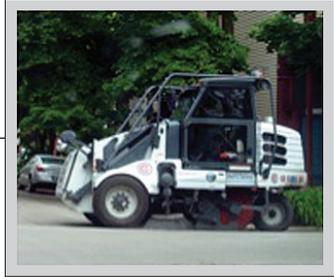
## 2. Broom Sweepers

- Typical “street sweeper” type.
- Rotating curb brushes with center pickup.
- Poly bristles only.
- Do not utilize water to clean the surface as this can have detrimental effects on the cleaning.
- Best for seasonal cleaning.
- Approximate cost: \$100 to \$120 per hour from a service company.

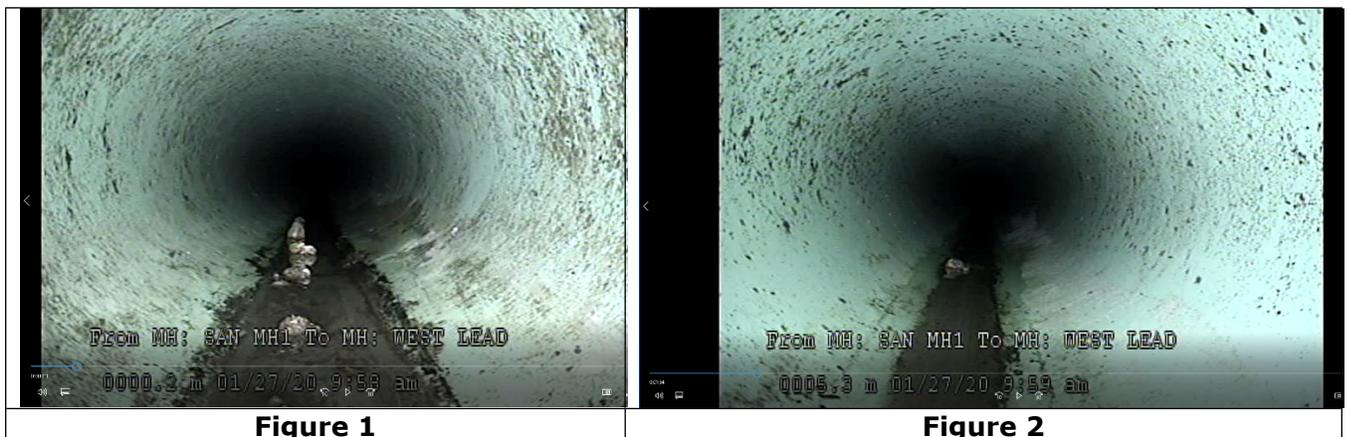
### Figures:

1. SAN MH1 to MH: West Lead (250mm PVC.) – Clear debris from 0.2m to 1.1m. Clear debris @ 5.3m.

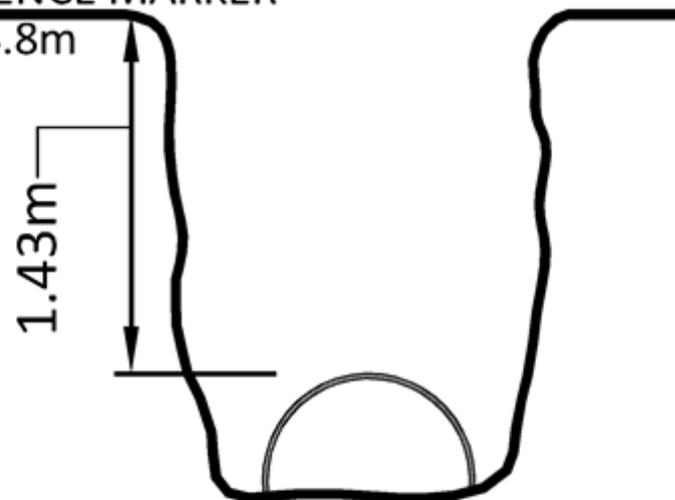
**TEST HOLE CROSS SECTION**

TH Date (m/d/yy)	2/13/20
<b>Utility Description</b>	
Utility Type	WM
Utility Material	PL
Utility Width (Field)	165 mm
Utility Width (Record)	- mm
Utility Direction	E-W
<b>Elevation of Utility</b>	
Top of Utility	263.37 m
Bottom of Utility	- m
<b>Depth From Grade</b>	
Top of Utility	1.43 m
Bottom of Utility	- m
Depth of Excavation	1.52 m
<b>Reference Marker</b>	
Easting	625409.06
Northing	4878010.36
Reference Elevation	264.80 m
Location	Center of Utility
ID'd By	Cut X
Surface Type	A

**REFERENCE MARKER**  
 EL. 264.8m

**Notes:**  
 FIELD VERIFIED APPROX. 165mm WATERMAIN. FIELD OBSERVATIONS INDICATE WATERMAIN IS WRAPPED IN BLACK PLASTIC WRAPPING.
